# **INDOOR AIR QUALITY ASSESSMENT**

**Beal School  
1 Maple Avenue  
Shrewsbury, MA 01545**

Prepared by:  
Massachusetts Department of Public Health  
Center for Environmental Health  
Emergency Response/Indoor Air Quality Program  
August 2006

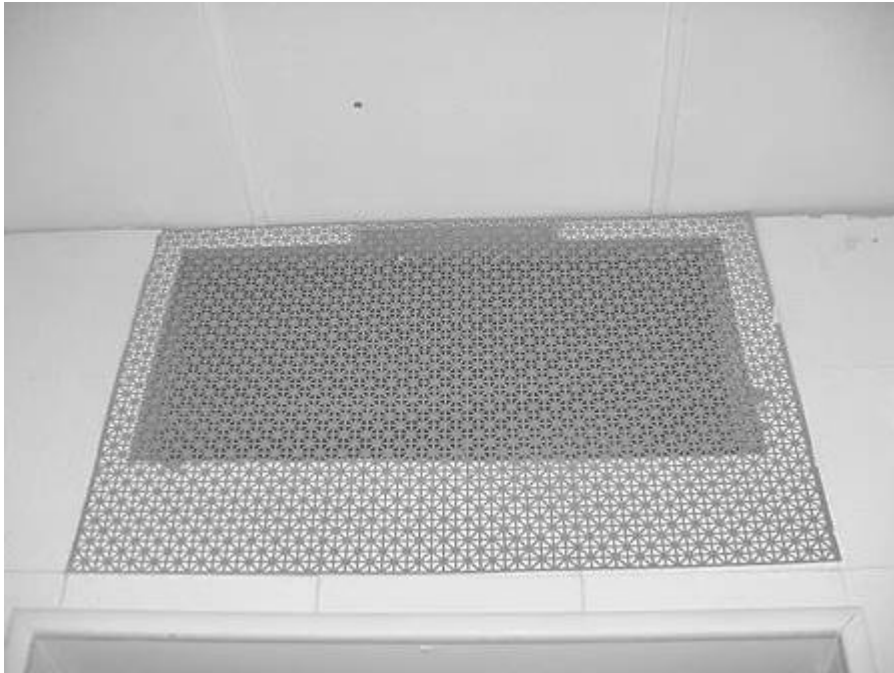
**Picture 1**

**Exhaust vent**

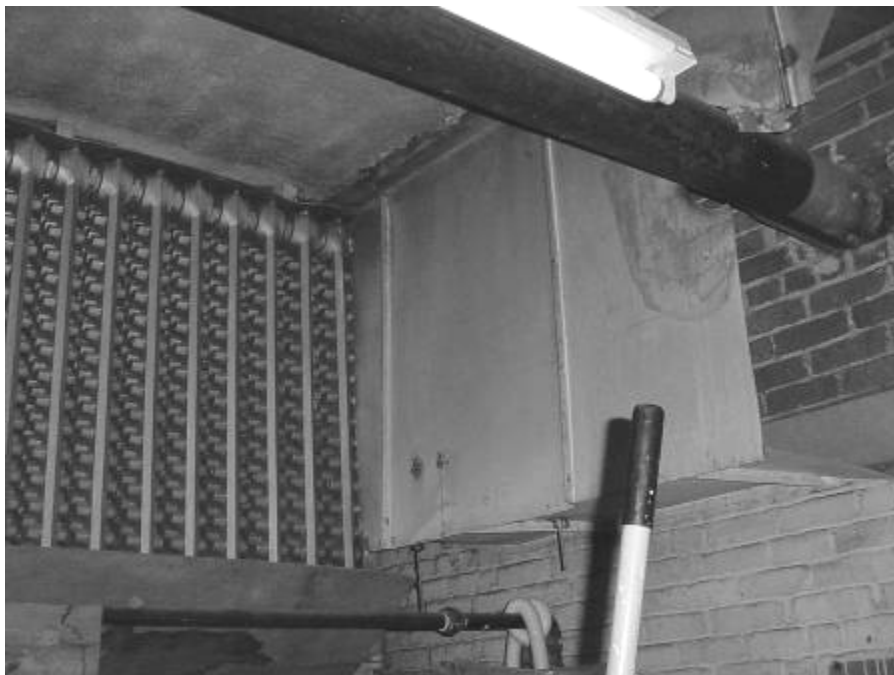
**Picture 2**

**Heating elements located in basement of school**

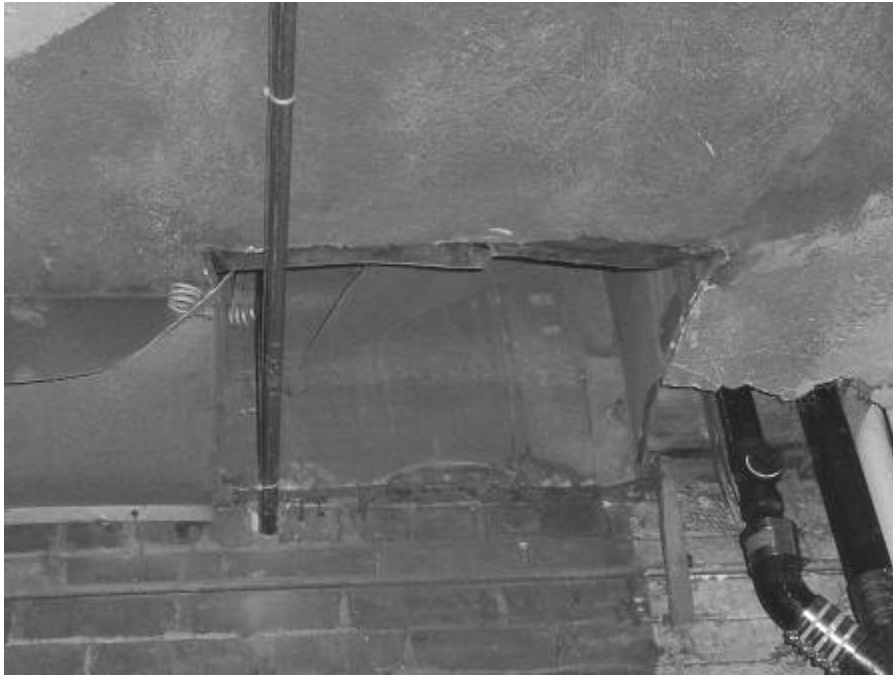
**Picture 3**

**Duct allowing heated air to rise**

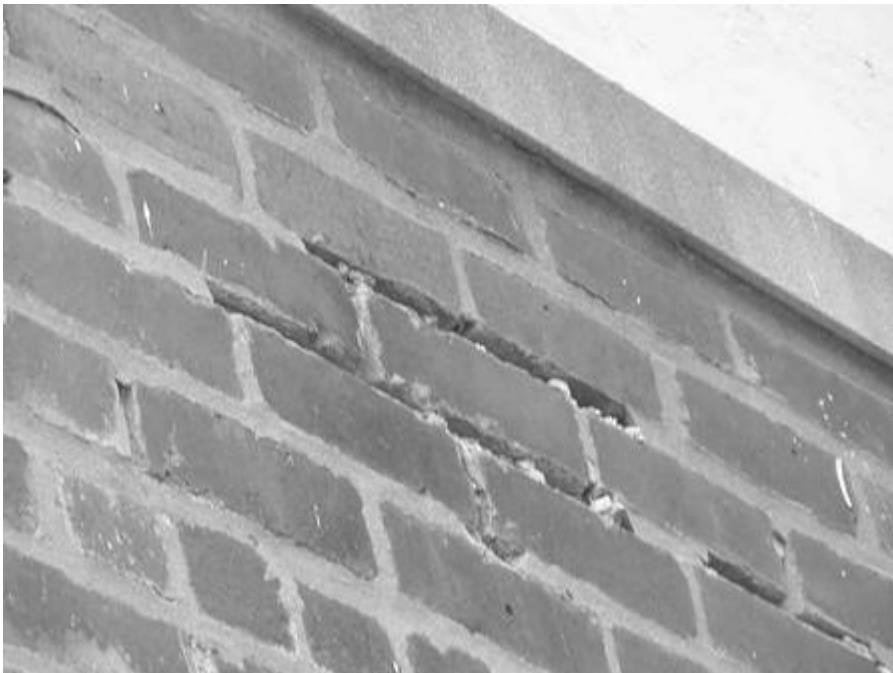
**Picture 4**

- Missing/damaged mortar and spaces in brick around the exterior of the building (Picture 4).
- Damage to the building foundation (i.e., fissures) (Picture 5).
- Spaces around wooden doorframes (Pictures 6 and 7).
- Damaged windows frames in a number of classrooms (Picture 8).

Breaches in the building exterior can allow water to penetrate the building. Repeated water penetration can result in chronic wetting of building materials, which can potentially lead to microbial growth. In addition, these breaches in the building envelope can provide a means of egress for pests/rodents into the building.

**Missing mortar**

5. Seal utility holes/breaches in exterior walls and install weather stripping around exterior doors to prevent water penetration, drafts and pest entry. Re-point brickwork where necessary.

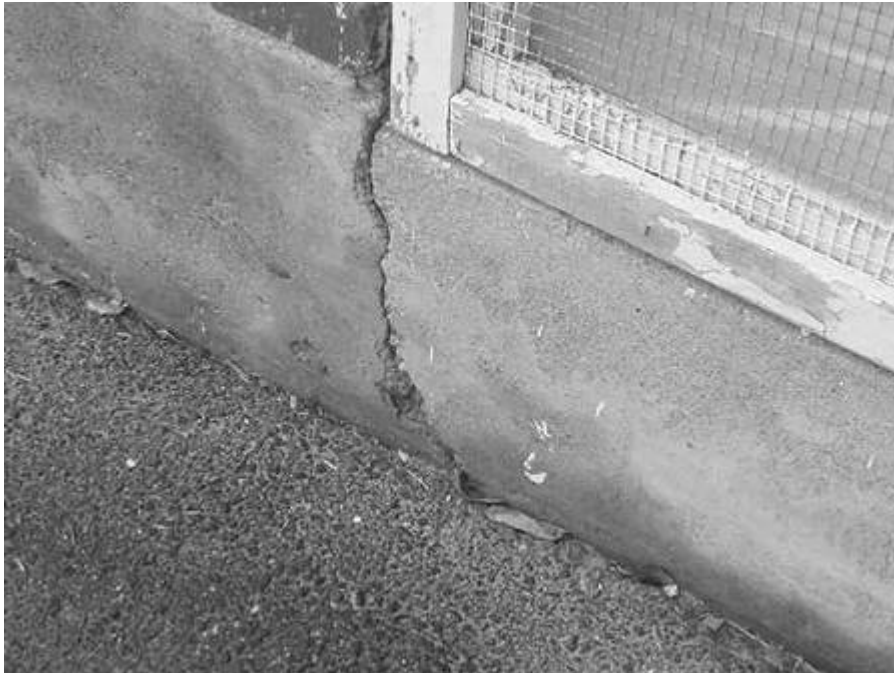
**Picture 5**

**Fissure in foundation**

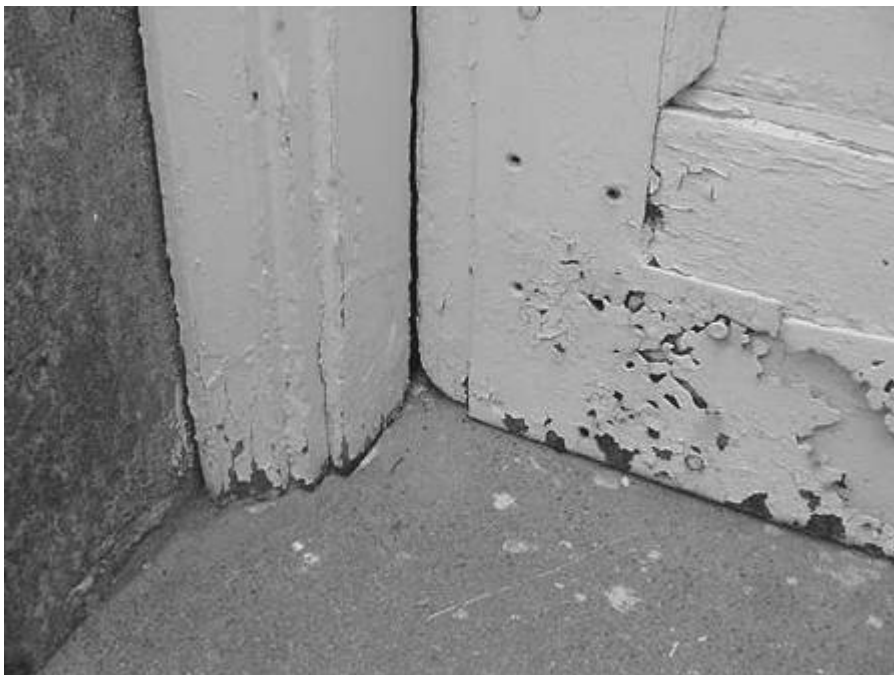
**Picture 6**

**Space between door and frame**

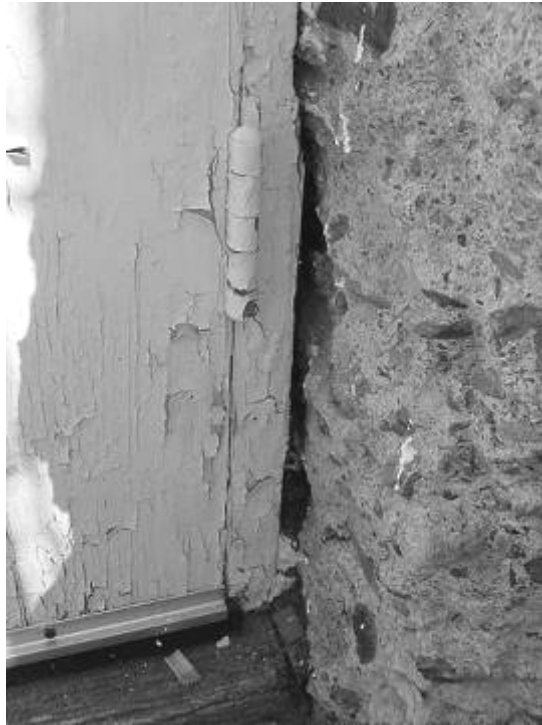
**Picture 7**

**Space between doorframe and exterior wall**

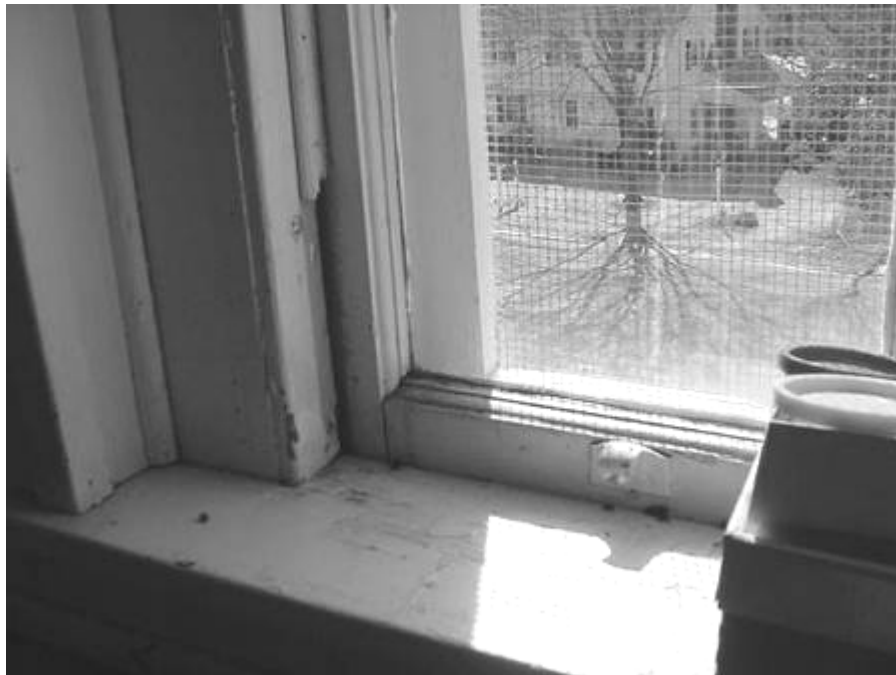
**Picture 8**

**Damaged window frame**

3. Seal abandoned ductwork and vents to prevent movement of dusts, odors and/or other materials into occupied areas.
4. Repair window frames where necessary to prevent water/pest intrusion or drafts.

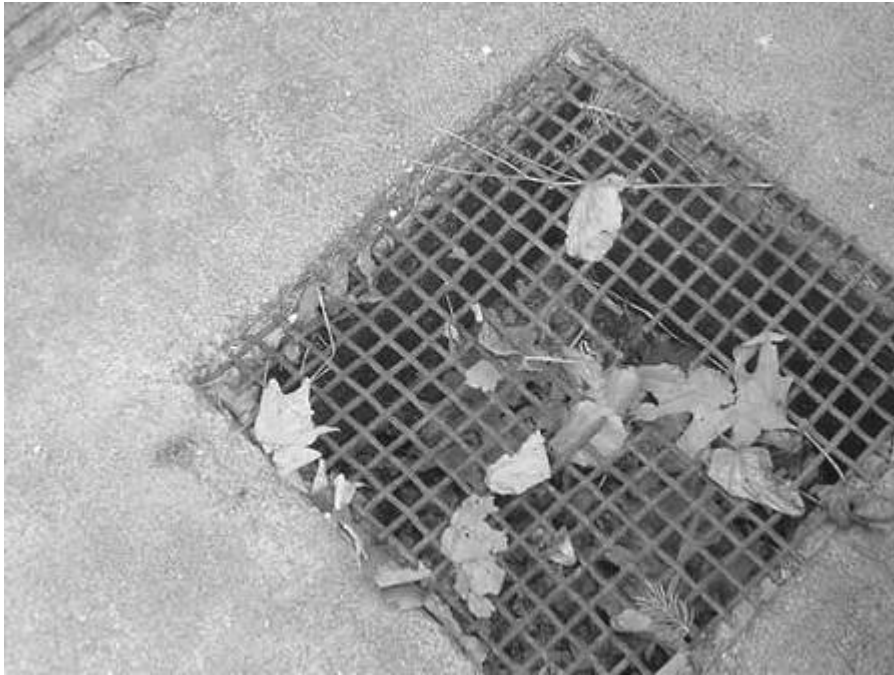
**Picture 9**

A number of drainage pits are located along the perimeter of the building. These pits are designed to drain water away from the building. Leaves, papers and other debris were observed on the floor of these pits (Picture 9). Such debris can prevent drainage and provide a source for mold growth and associated odors.

**Debris in drainage pit**

8. Remove leaves and debris from subterranean pits seasonally; ensure proper drainage.
9. Seal breaches between sink countertops and backsplashes to prevent damage. Replace damaged materials where necessary.

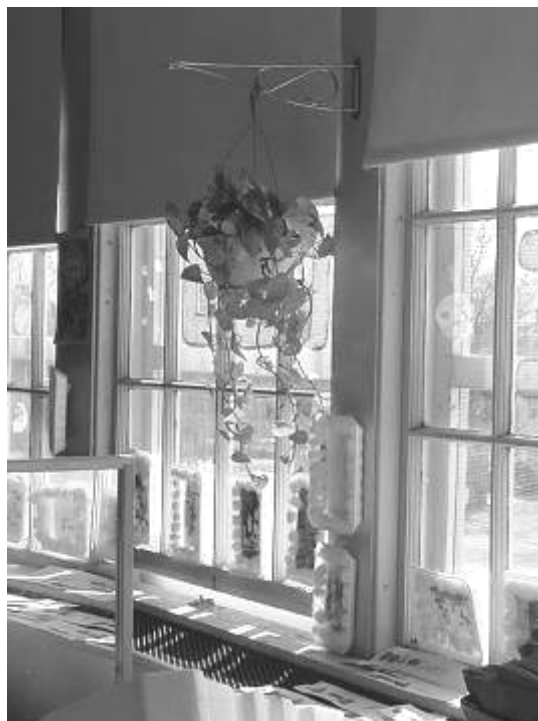
**Picture 10**

Several classrooms contained a number of plants (Picture 10). In one area, a plant was observed on a carpeted floor (Picture 11). Plants, soil and drip pans can serve as sources of mold

growth, and thus should be properly maintained. Placement of plants on porous materials (i.e., carpet, paper products) should be avoided since these materials are sources for mold growth.

**Plants in classroom**

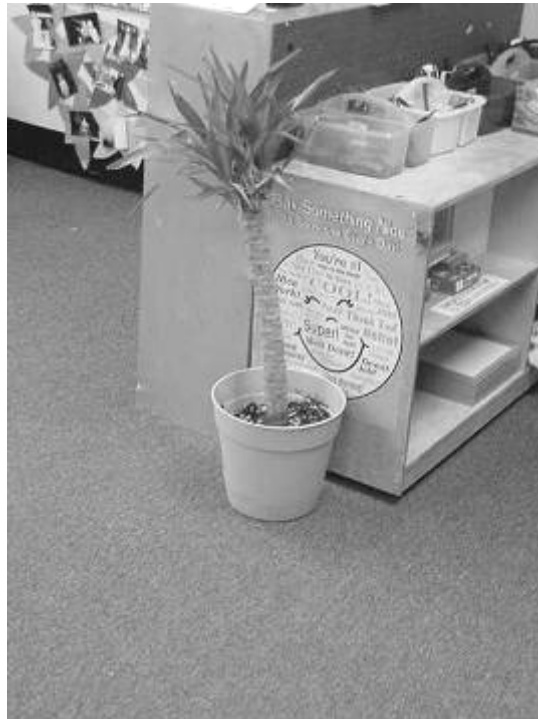
**Picture 11**

**Plant on carpet**

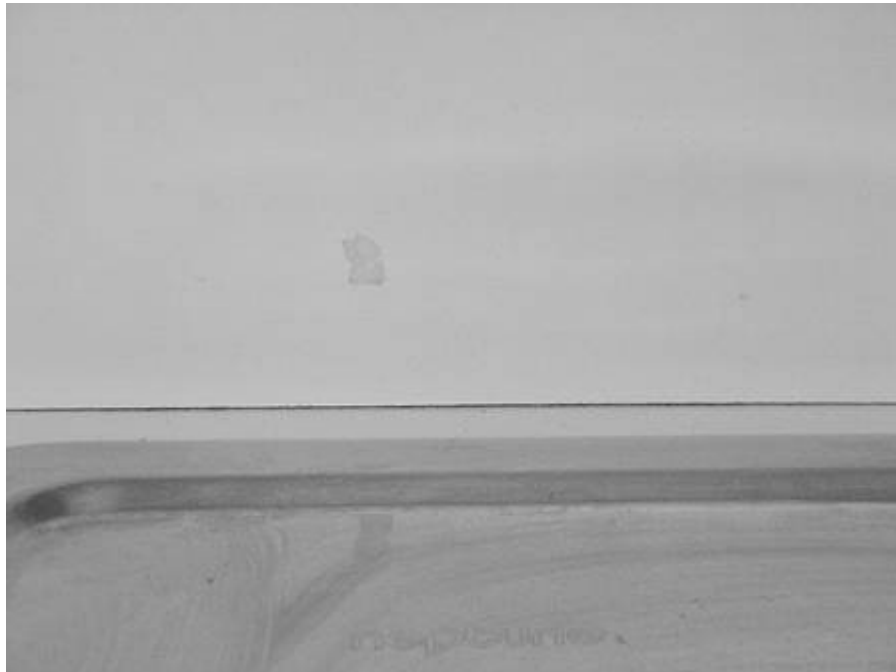
**Picture 12**

Spaces between the sink countertop and backsplash were noted in several classrooms (Picture 12/Table 1). Improper drainage or sink overflow can lead to water penetration to countertop wood, the cabinet interior and areas behind cabinets. Like other porous materials, if these materials become wet repeatedly they can provide a medium for mold growth.

**Space between sink countertop and backsplash**

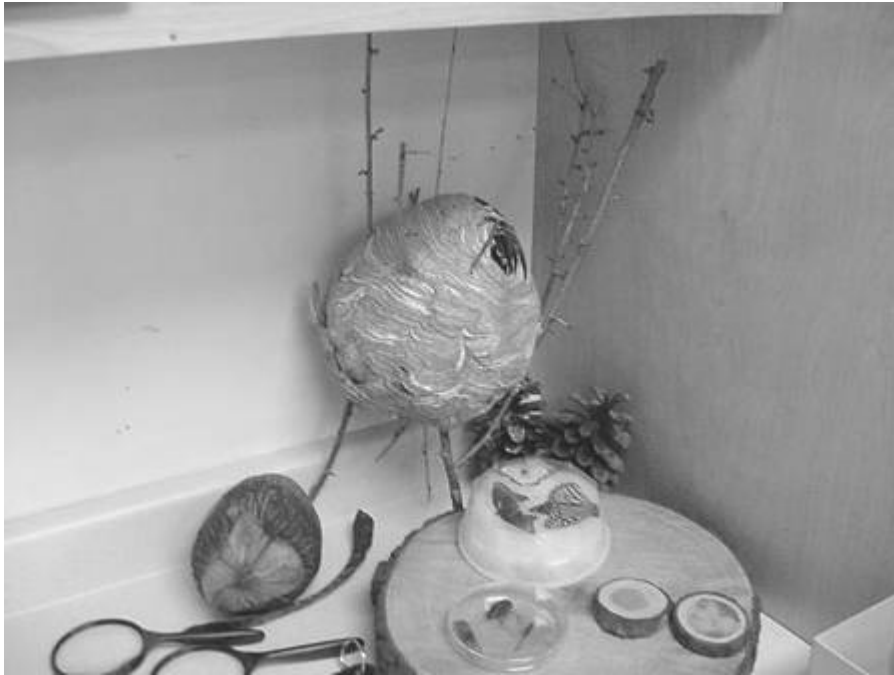
**Picture 13**

An inactive insect nest was observed in a classroom (Picture 13). Nests can contain bacteria and may be a source of allergenic material. Nests should be placed in resealable bags to prevent aerosolization of allergenic material.

**Insect nest**

10. Place nests and similar allergen containing materials in resealable clear bags or clear boxes to prevent exposure to allergenic materials.
11. Clean and maintain dehumidifiers as per the manufacture's instructions.

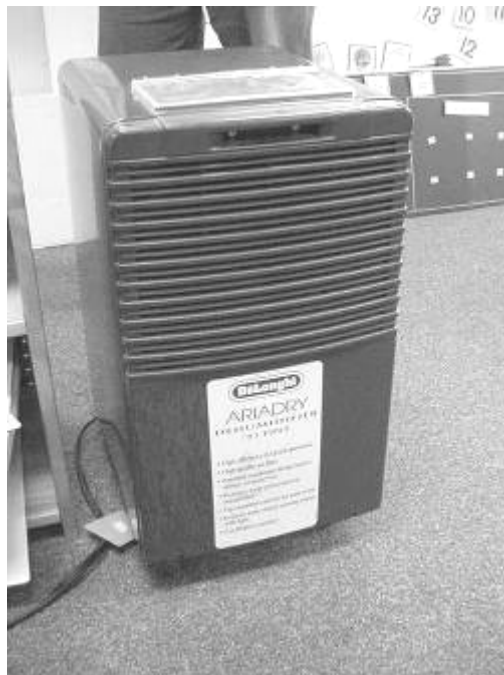
**Picture 14**

Lastly, a dehumidifier was observed in one classroom (Picture 14). Reservoirs of dehumidifiers are designed to catch water during operation. Reservoirs should be emptied and cleaned regularly to prevent microbial and/or bacterial growth.

**Dehumidifier on carpet**

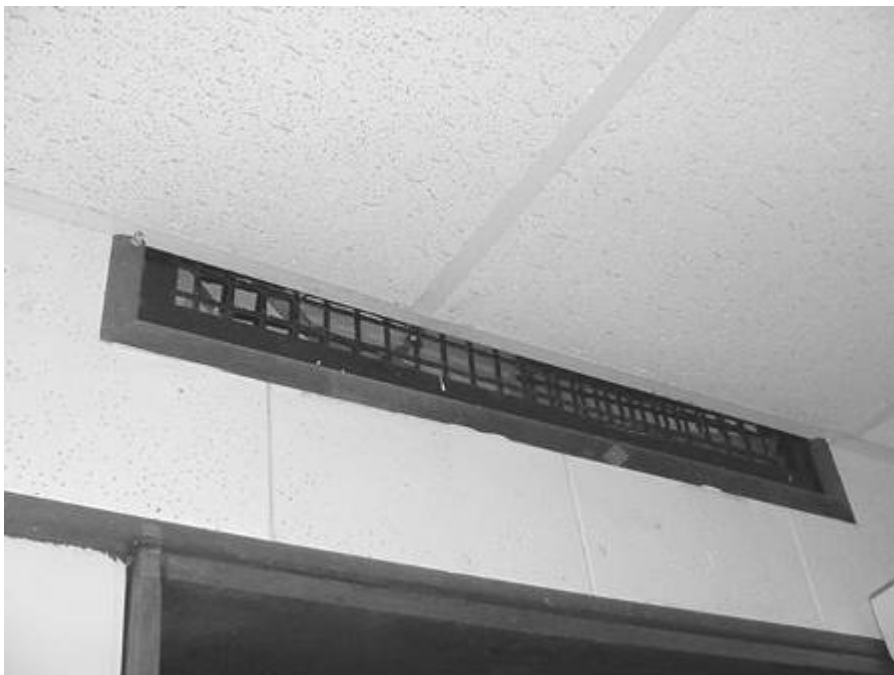
**Picture 16**

As previously discussed, drop ceiling tile systems were installed to prevent movement of dust and materials from the original plaster ceiling. In some classrooms, the ceiling tile system divides the exhaust vents (Picture 16). These unsealed exhaust vents facilitate the movement of materials from areas above the drop ceiling system into occupant areas. In addition, many of the panels to the abandoned ductwork were removed and are no longer intact (Pictures 17 and 18). If no longer in use, the ductwork should be sealed completely to prevent movement of materials, odors and/or pests within the building.

**Ceiling tile dividing vent**

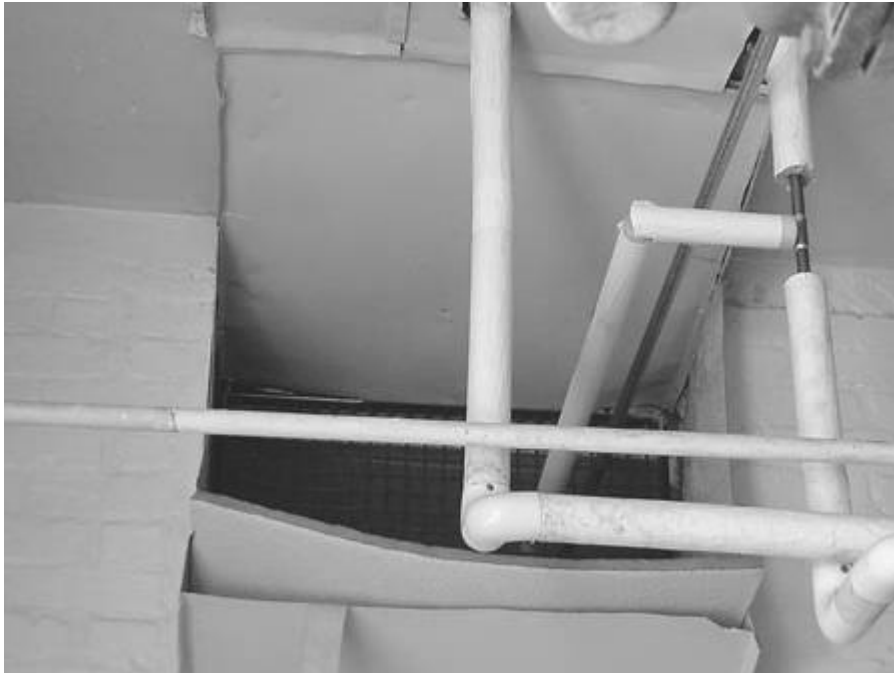
**Picture 17**

**Unsealed abandoned ductwork**

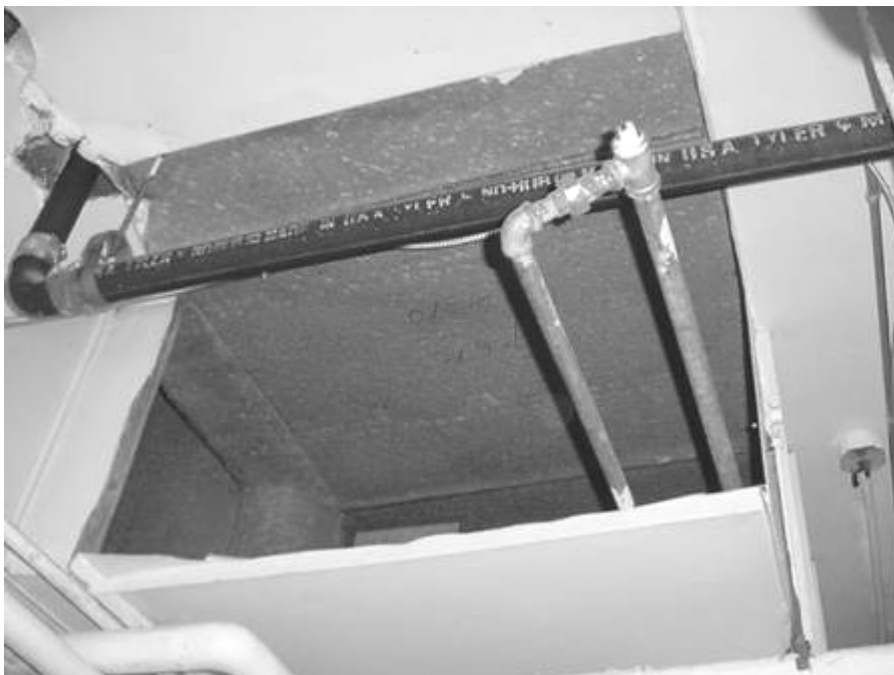
**Picture 18**

**Unsealed abandoned ductwork**

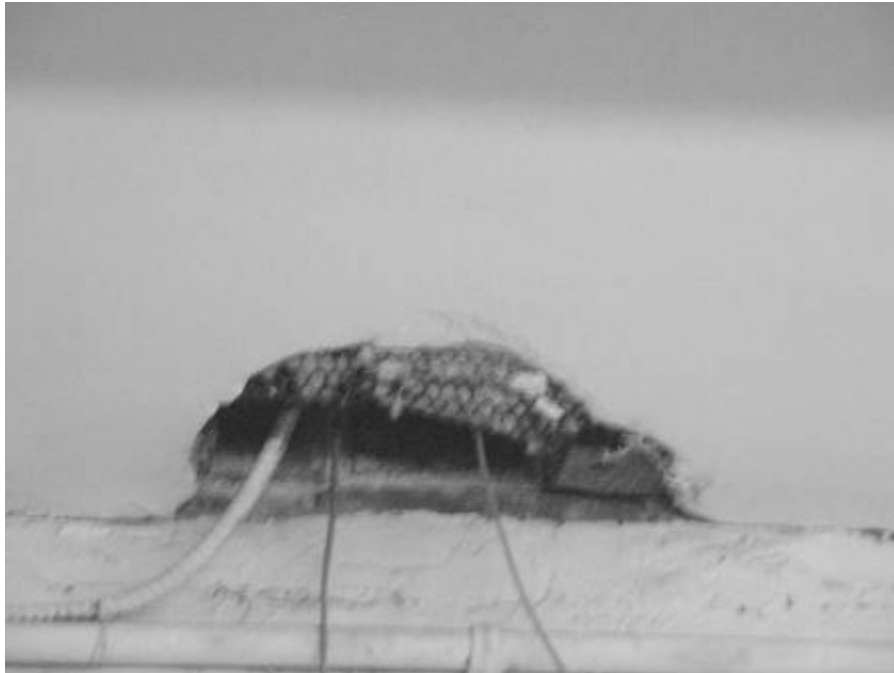
**Picture 19**

Open utility holes and breaches in walls were observed in a number of areas (Picture 19). Missing and ajar ceiling tiles were also observed. Open utility holes and missing/ajar ceiling tiles can provide a pathway for the movement of drafts, odors and particulate matter.

**Breach in wall**

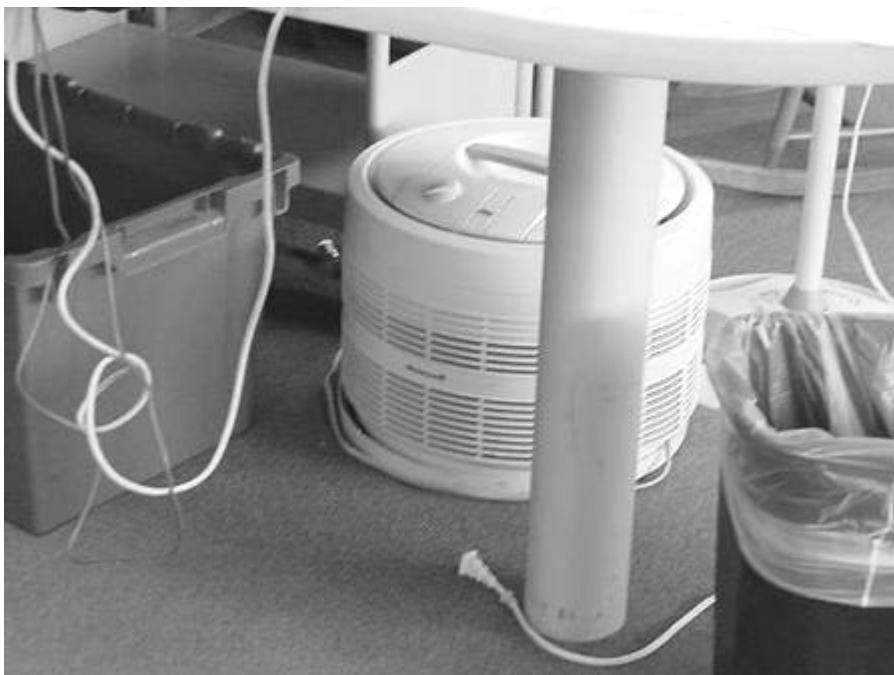
**Picture 20**

Some classrooms contained portable air purifiers (Picture 20). This equipment is normally equipped with filters that should be cleaned or changed as per manufacturer's instructions to avoid the build up and re-aerosolization of dirt, dust and particulate matter. In addition, air purifiers should be placed within the breathing zone rather than at floor level.

**Air Purifier**
